Noatak Water Treatment Plant

ANTHC-09-D-52948

Site & Facility Assessment Report

October 25, 2009
100% DRAFT

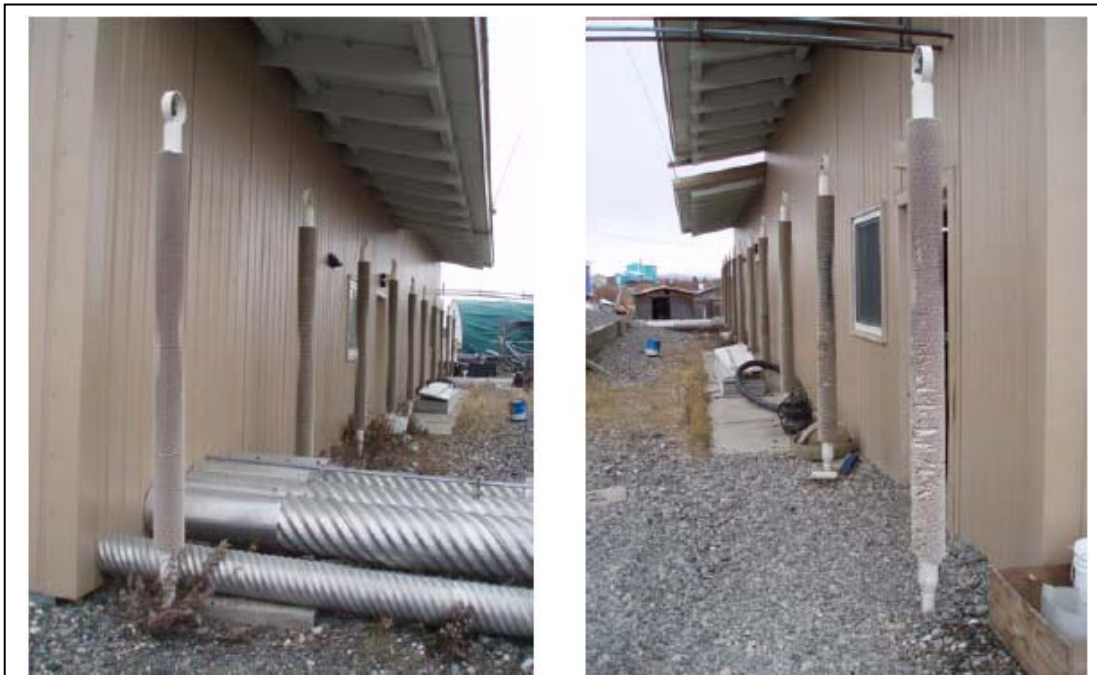
Figure 4. Thermosyphons along West Wall (Looking South & North)

Although the thermosyphon system is impacted, it is operating as designed. The units continue to function when the evaporator temperature is above 60°F. There is no 'setpoint' for thermosyphon operation to start at 32°F. Rather, these thermosyphons move heat against gravity whenever the upper portion of the unit (Typically the condenser) is colder than the lower portion of the unit (typically the evaporator). When the air temperature is below the evaporator temperature, the thermosyphon will release heat to the air and the evaporator temperature will rapidly equilibrate along its length.

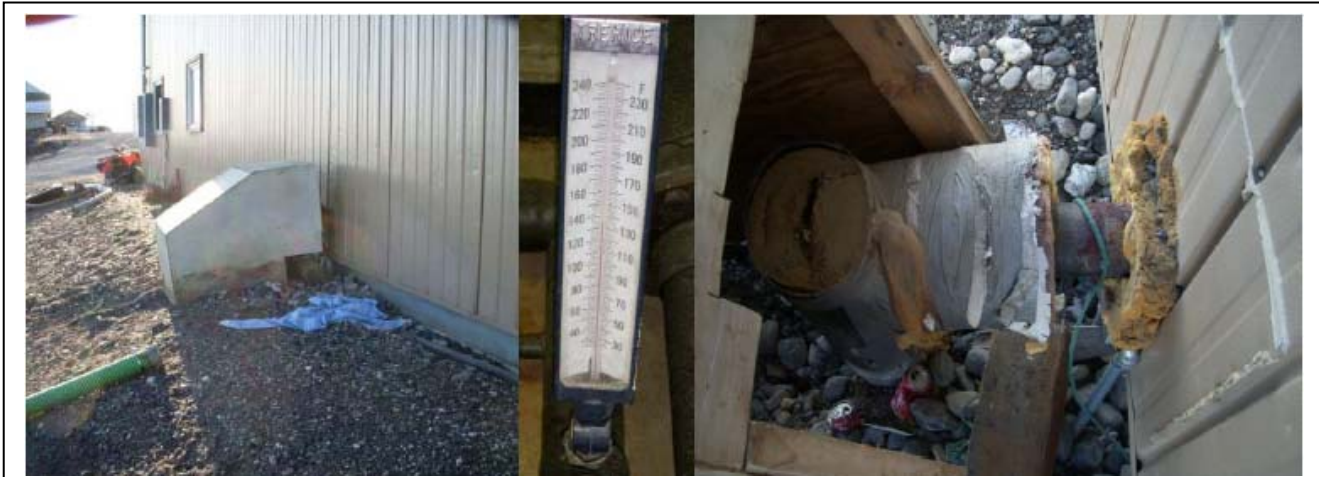
Another source of heat upon the plant subsoils to consider consists of the tempered water circulating between the community power generation plant and the water treatment plant. The water line is encased by 4x8 arctic pipe to insulate the ground from heat transfer from the tempered water. According to the plant operator, the amount of waste heat circulating through the plan has gone down since the new school was built. The pipe enters the plant above the exterior grade, so it is unlikely to be adding to the heat load of the plant foundation. It would be a contributing factor if the line is leaking water along its joints near the plant foundation. This leak of tempered water, in conjunction with the graveled soil characteristics, could contribute to

the heat load of the foundation. The circulation lines would need to be excavated along a 20-foot length extending from the entry point to the plant to confirm leakage.

Figure 5. Waste Heat Circulation Line at Water Treatment Plant

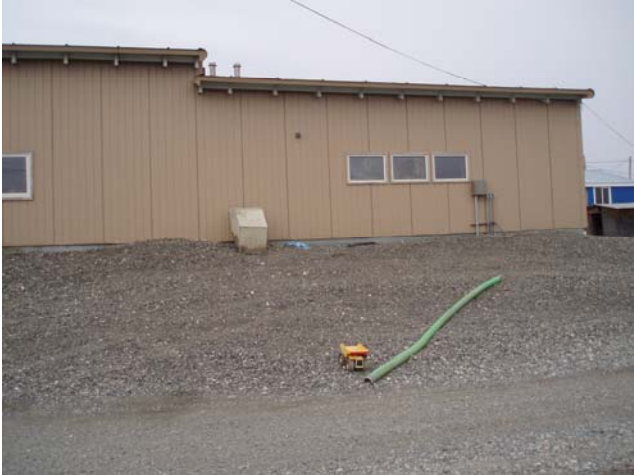
The supply manifolds have also settled toward the concrete slab floor indicating the subsurface soils supporting the arctic pipe are destabilizing. Outside the east wall the gravel bed of cover material (covering the supply/return lines from the plant to the community) also exhibits depressions indicating permafrost thawing in the subsurface soils. These depression may extend to areas under the concrete floor.

S03
Graveled Bank Along East Wall

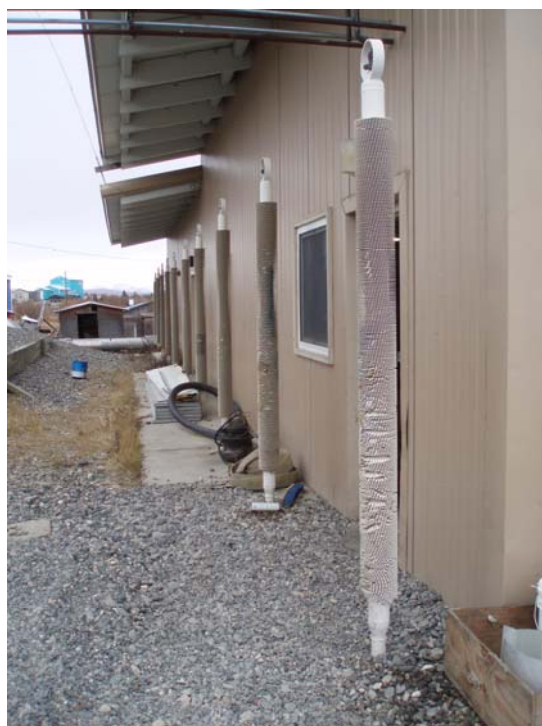
S06
Foundation Thermosiphons Along West Wall

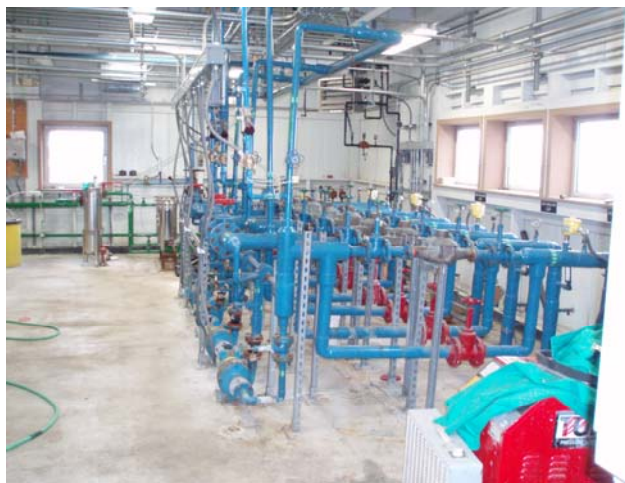
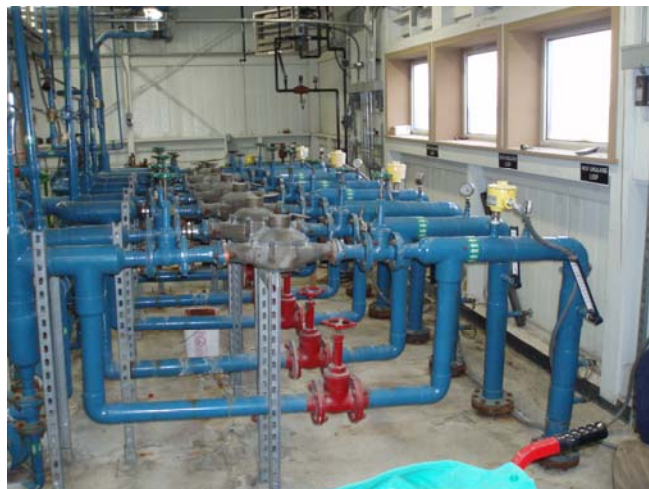
The major impact that will likely present itself first is the failure of the water supply and return lines where they connect to the manifolds inside the plant. The manifolds were designed to connect to the supply line (4"x12" HDPE encased in arctic pipe) approximately 8-inches above the concrete floor surface inside the plant. Most of the manifolds have settled to the point where these connections are close to, or resting upon, the concrete floor. If this settlement continues, these connections will fail.

S07
Loop Circulator Piping Manifold

S08
Loop Circulator Piping Manifold

- Extend the HDPE pipe passing through the concrete floor to a height that returns the manifold connections back to their design height (approximately 8-inches above the floor line). This will require removal of approximately 40-square feet of concrete floor and all the materials normally required to form a connecting between two similar HDPE pipes. In lieu of pouring new concrete to fill the channel created around the manifolds, it should be filled with rigid EPS foam board. This will eliminate future risk to the connections should the pipes settle.
- Reroute water lines through the wall as opposed to through the floor to remove any contributing heat load radiating from the insulated pipes or from water leaks.

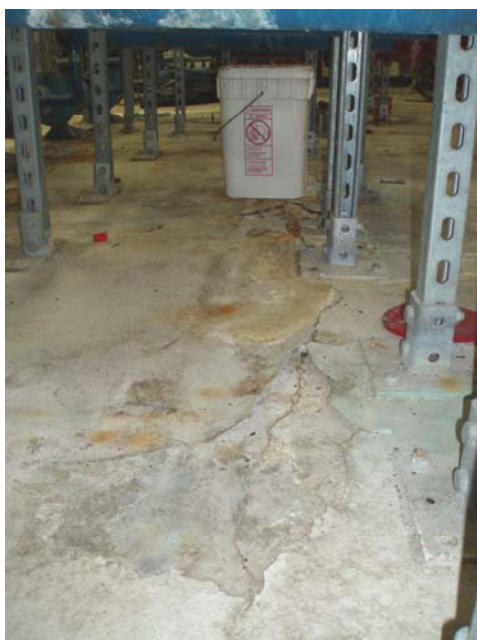
The next impact will be upon the concrete floor and perimeter wall foundation. The northeast corner of the perimeter wall has already settled up to 4-inches. Floor cracks within the plant along the building midpoint indicate the entire eastern half of the building is settling. Eventually, this continued settlement will cause damage and potential failure to the plant's roof system and foundation walls along the north and south faces.

**S11
Floor Cracks Along Settlement Line Below
Water Circulation Manifolds**

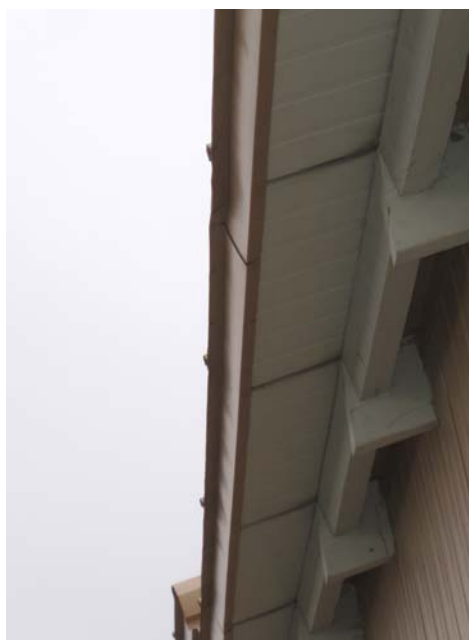
**S12
Buckled Soffit Indicating Wall System Stress
dueto Building Settlement**
