Noatak Water Treatment Plant

ANTHC-09-D-52948

Site & Facility Assessment Report

October 25, 2009
100% DRAFT

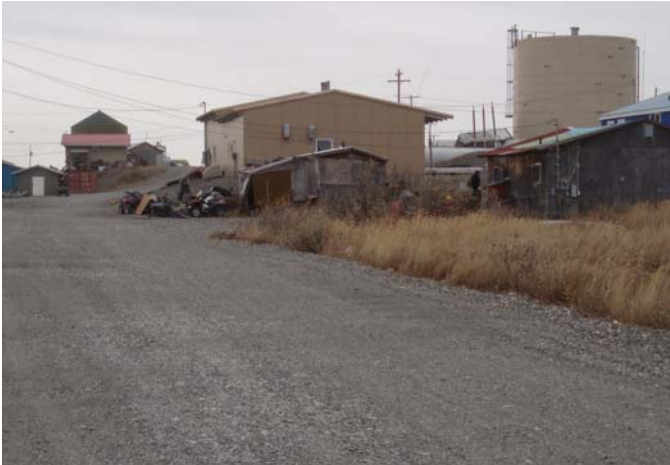
S01
Noatak WTP (Looking South)

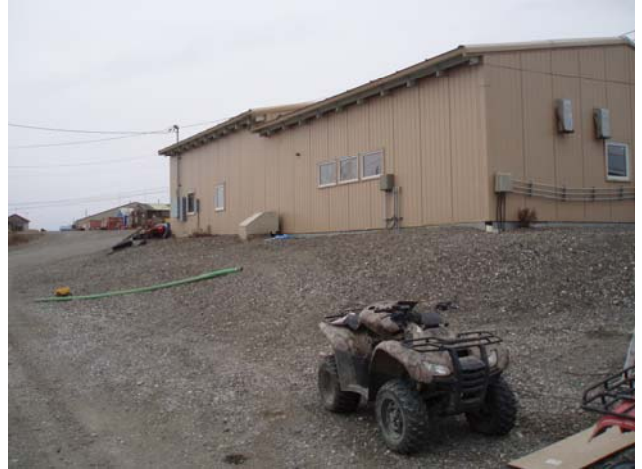
S02
WTP East Wall

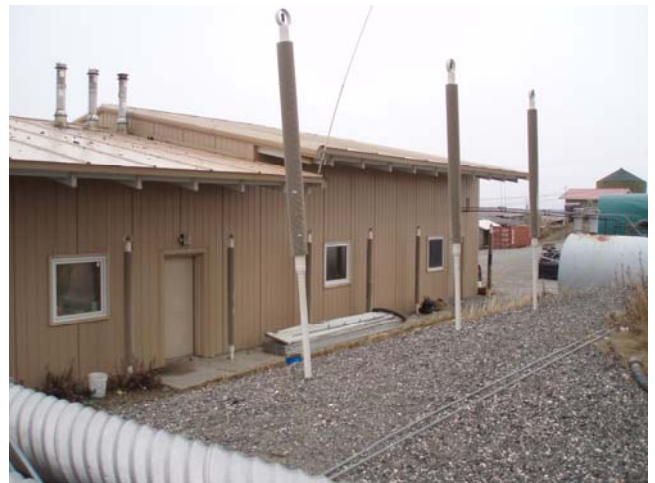
S04
WTP West Wall

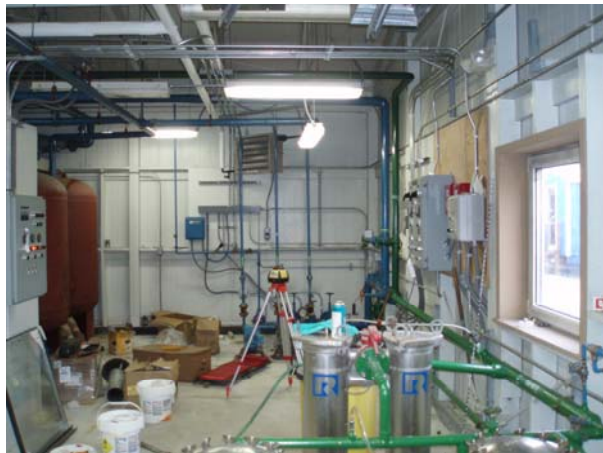
**S10
Cartridge Filters and Pressure Pump**

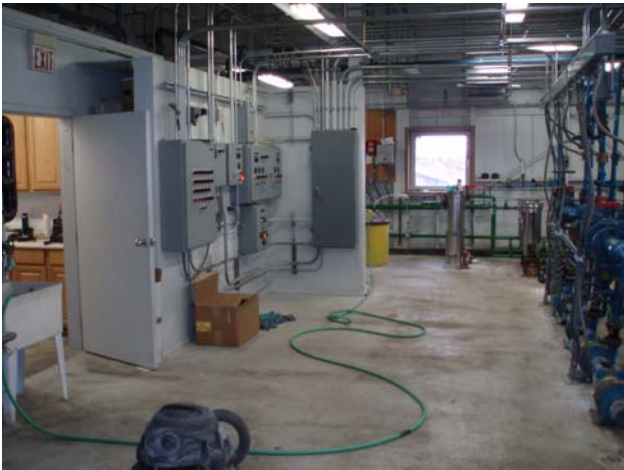
S13
Building Mid-Line and Electrical Panels

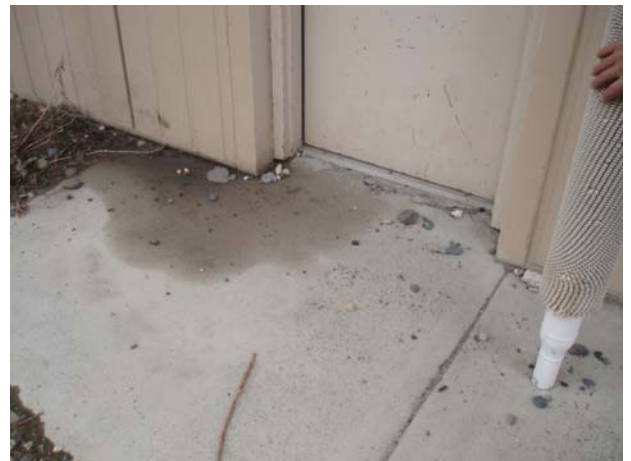
S16
WTP Entry Concrete Landing
