Noatak Water Treatment Plant

ANTHC-09-D-52948

Site & Facility Assessment Report

October 25, 2009
100% DRAFT

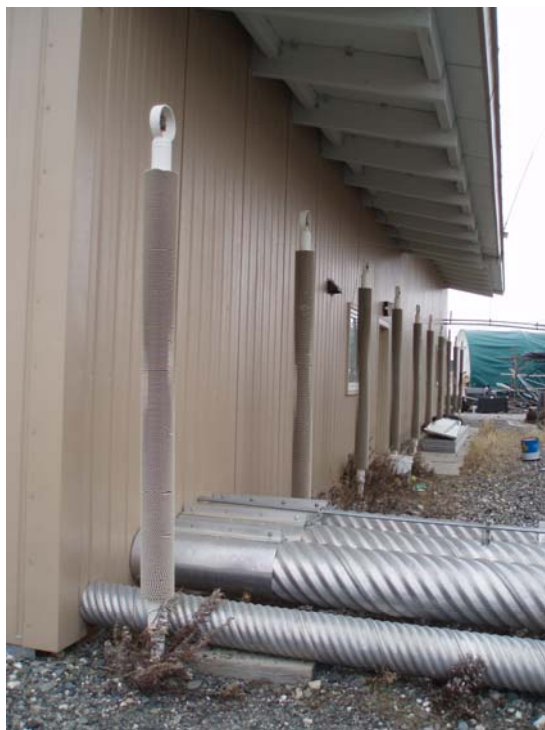
S05
Water Lines from WST to WTP

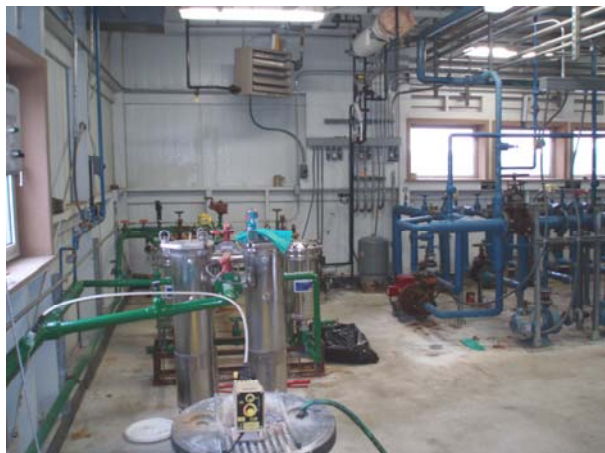
**S09
Cartridge Filters**

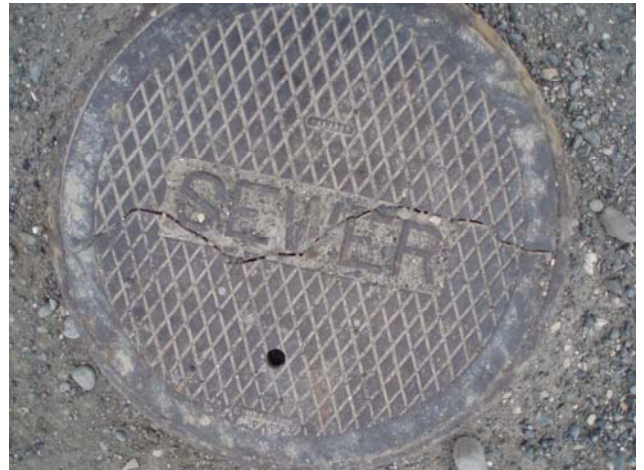
S14
Access Man-Hole

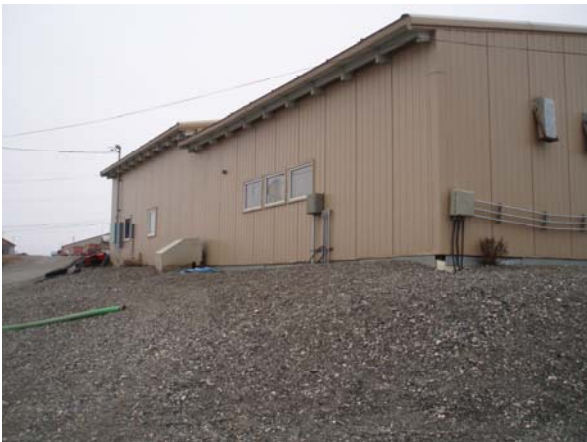
The supply manifolds have also settled toward the concrete slab floor indicating the subsurface soils supporting the arctic pipe are destabilizing. Outside the east wall the gravel bed of cover material (covering the supply/return lines from the plant to the community) also exhibits depressions indicating permafrost thawing in the subsurface soils. These depression may extend to areas under the concrete floor.

S15
**Sloped Gravel Cover Over Water Circulation
Lines to Community**
